REFERENCE

Bolton Upon Dearne Ex-Servicemens Club, Rotherham

Concrete repair and colour matched protection to external facade which had been suffering with spalling concrete due to carbonation.

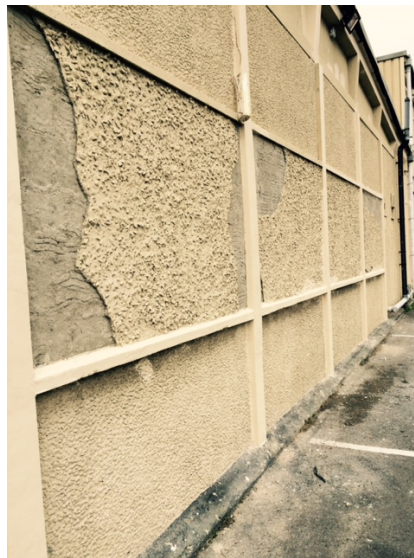
Before

This unusual building structure encompasses concrete pillars with precast concrete panels attached. Previous alterations had been carried out over time and the windows had been blocked off. The facade comprised of a pebble dash effect which had also been sprayed with concrete.

The pillars and panels required repairing with Rust Inhibitor M which provides long term corrosion protection along with Betofix R2, a high build fast curing concrete repair mortar. OS Concrete Fill was then applied as a filler paint and blended with a colour matched coating of Concrete Acrylic to give a stipple effect finish and provides excellent anti-carbonation and weathering protection.
